Transmission Line Routing Permit Application

Faribault Energy Park, LLC
Minneapolis, MN

March 2004

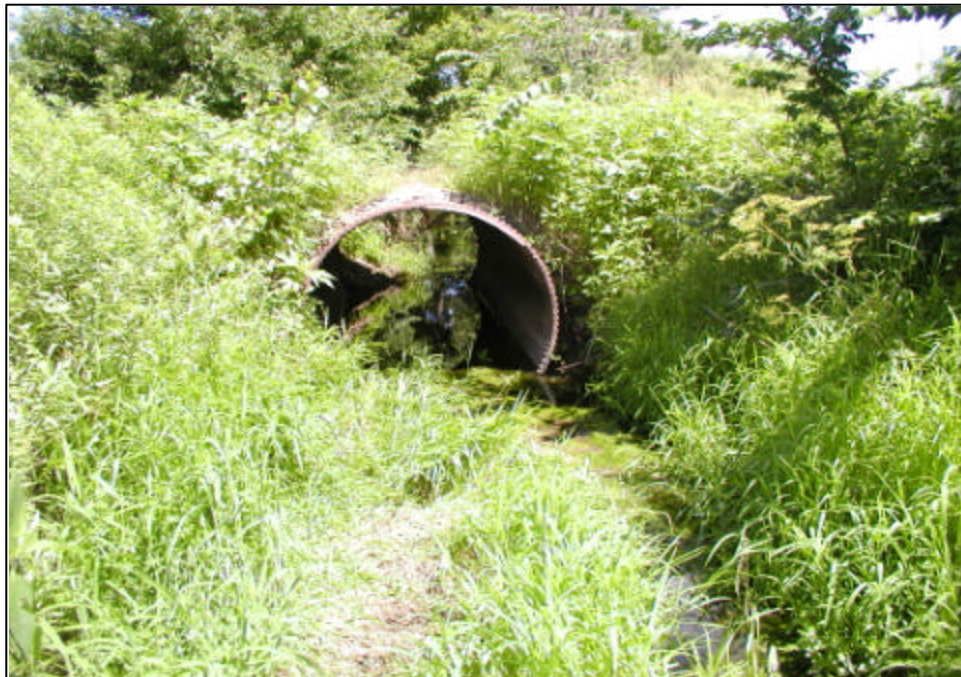
Photo 8: Looking north at culvert located on north end of Wetland D. Data Point No. D-1 taken at bottom of drainageway in foreground.

long, 5-foot diameter riveted steel culvert is located in the drainageway at the north property line providing a farm equipment access across the drainageway. There appears to be permanent to semi-permanent water in the drainageway since minnows and frogs were observed. At the time of the field survey water was flowing to the northeast.

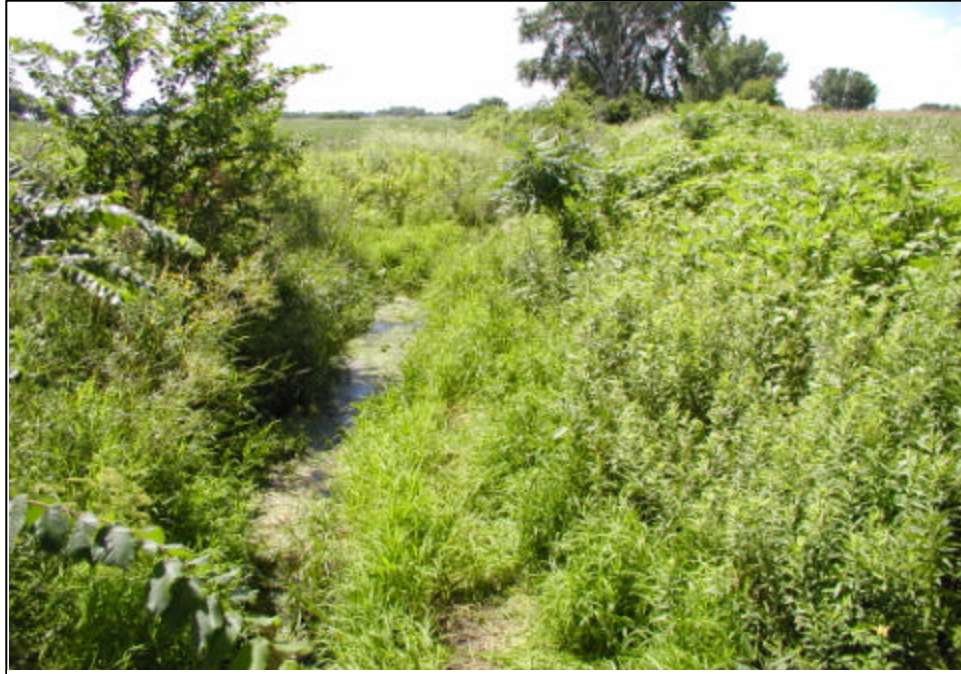
Photo 9: Looking south at Wetland D. Photo taken from south end of culvert. Note – soybean field to east and cornfield to west. Data Point No. D-2 taken at top of bank to west.

Data Point D-1 shows wetland vegetation and hydrology. The soils appear to be depositional and exhibit an aquic moisture regime. Data Point D-2 taken at the top of the west bank shows that even though wetland vegetation and hydric soil are present, sufficient hydrology indicators are not present to call the area on the top of the bank a wetland. This is supported by similar observations from Data Point D-3 taken at the top of the east bank. Therefore, only the drainageway channel and sideslopes are considered wetland at these locations covering an area of approximately 14,800 square feet (0.34 acres).

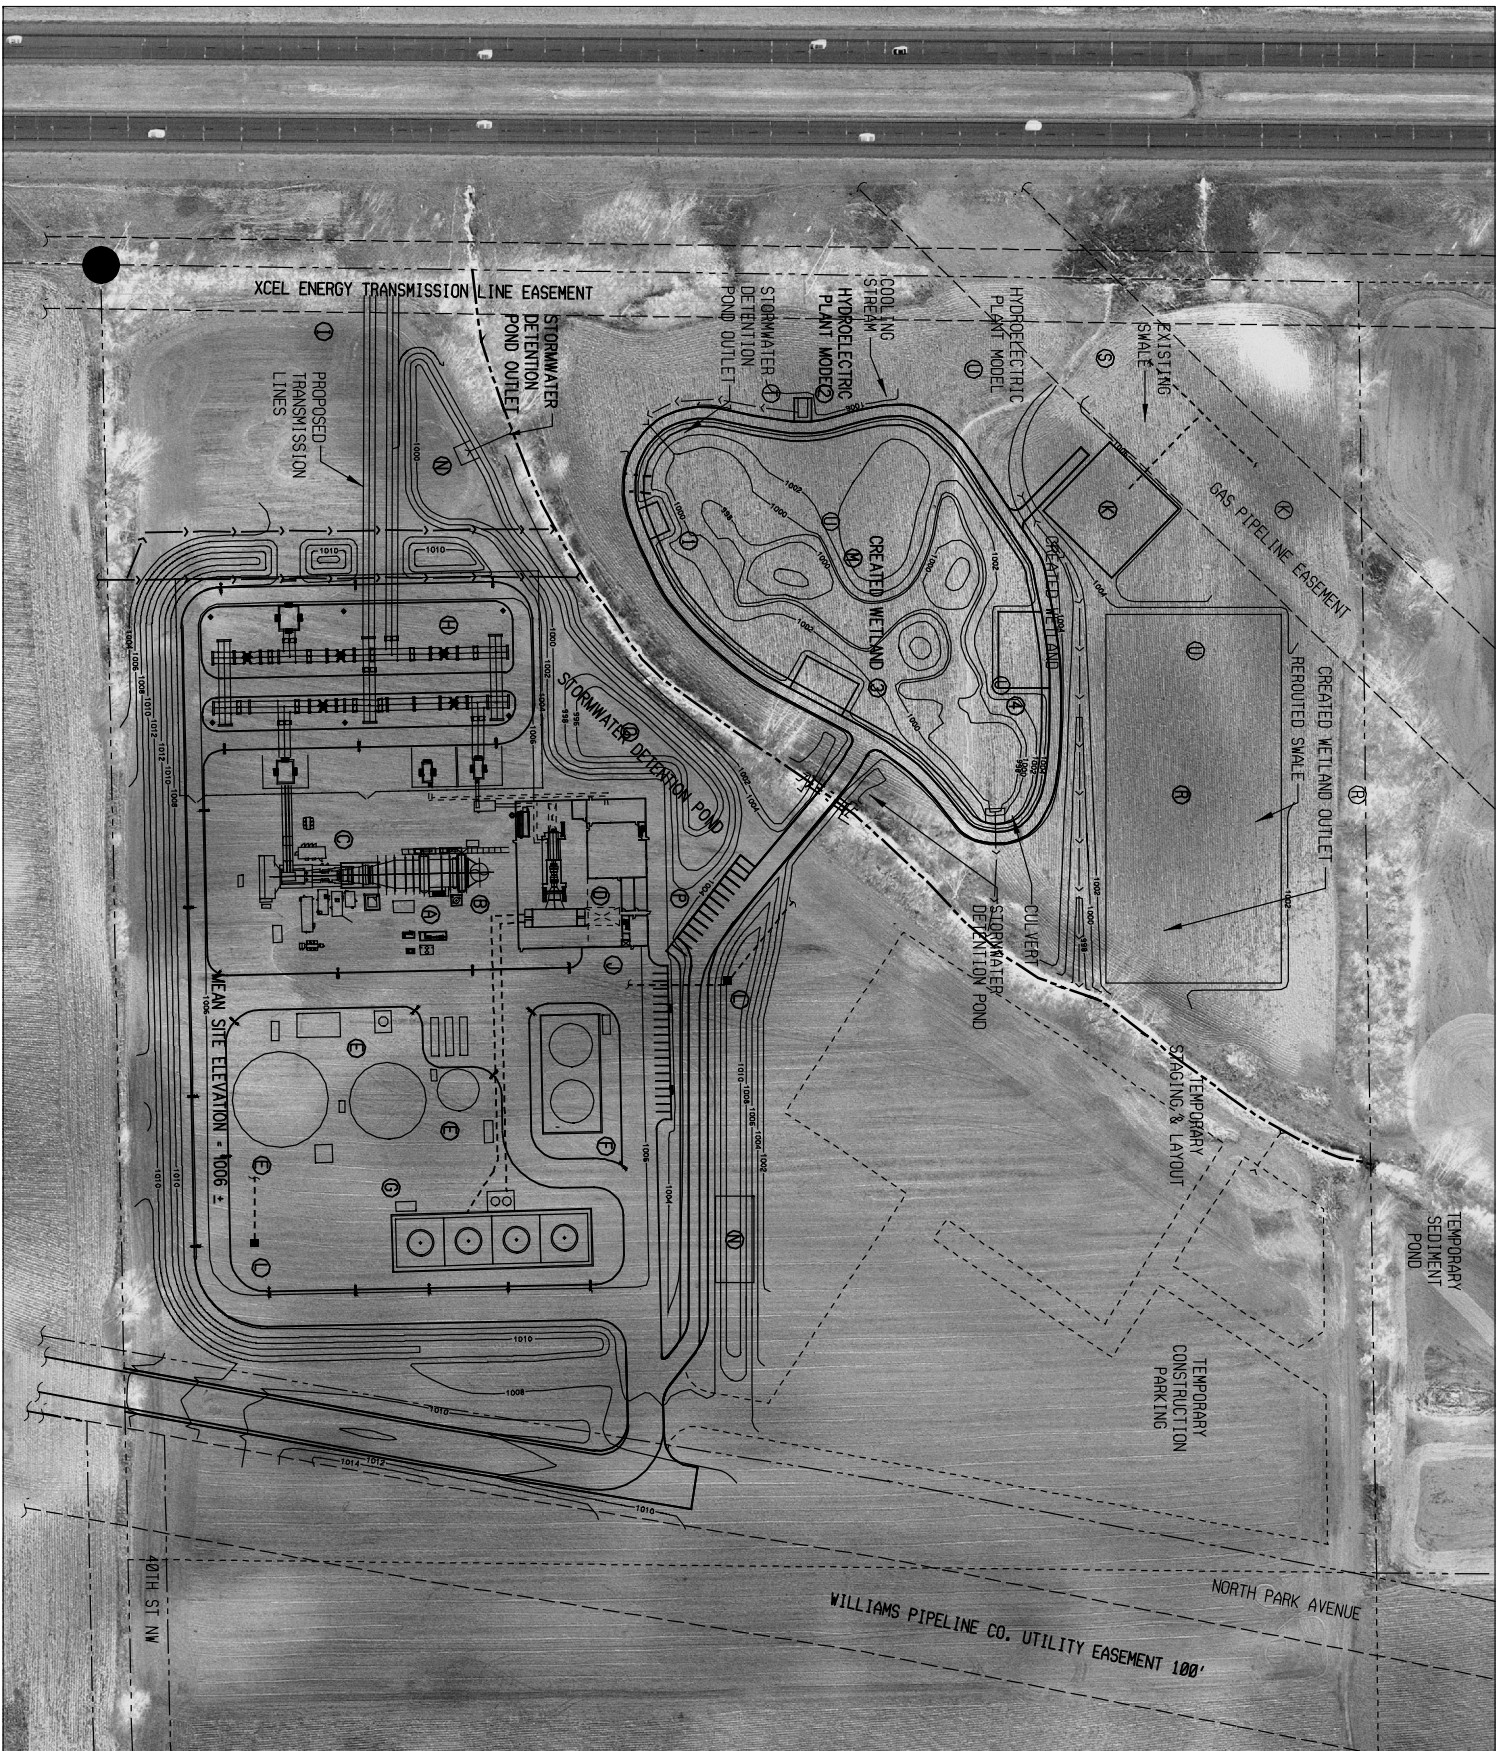
FARIBAULT ENERGY PARK MAJOR FACILITIES	
FACILITY	
A.	HEAT RECOVERY STEAM GENERATOR
B.	STACK
C.	NATURAL GAS TURBINE GENERATOR
D.	STEAM TURBINE GENERATOR
E.	WATER STORAGE TANK
F.	FUEL OIL STORAGE TANKS
G.	COOLING TOWER
H.	ELECTRICAL SUBSTATION
I.	TRANSMISSION INTERCONNECTION
J.	STEAM TURBINE BUILDING
K.	NATURAL GAS VALVE & METERING STATION
L.	WATER WELL
M.	CREATED WETLAND
N.	SEPTIC ABSORPTION FIELD
O.	STORMWATER DETENTION POND
P.	PUBLIC PARKING & INTERPRETIVE DISPLAY AREA
Q.	NOT USED
R.	FUTURE GREENHOUSE
S.	NATURAL GAS SUPPLY PIPELINE
T.	PLANT EFFLUENT PIPELINE
U.	ENERGY EDUCATION CENTER
V.	(HYDRO, SOLAR, WIND, OTHER)

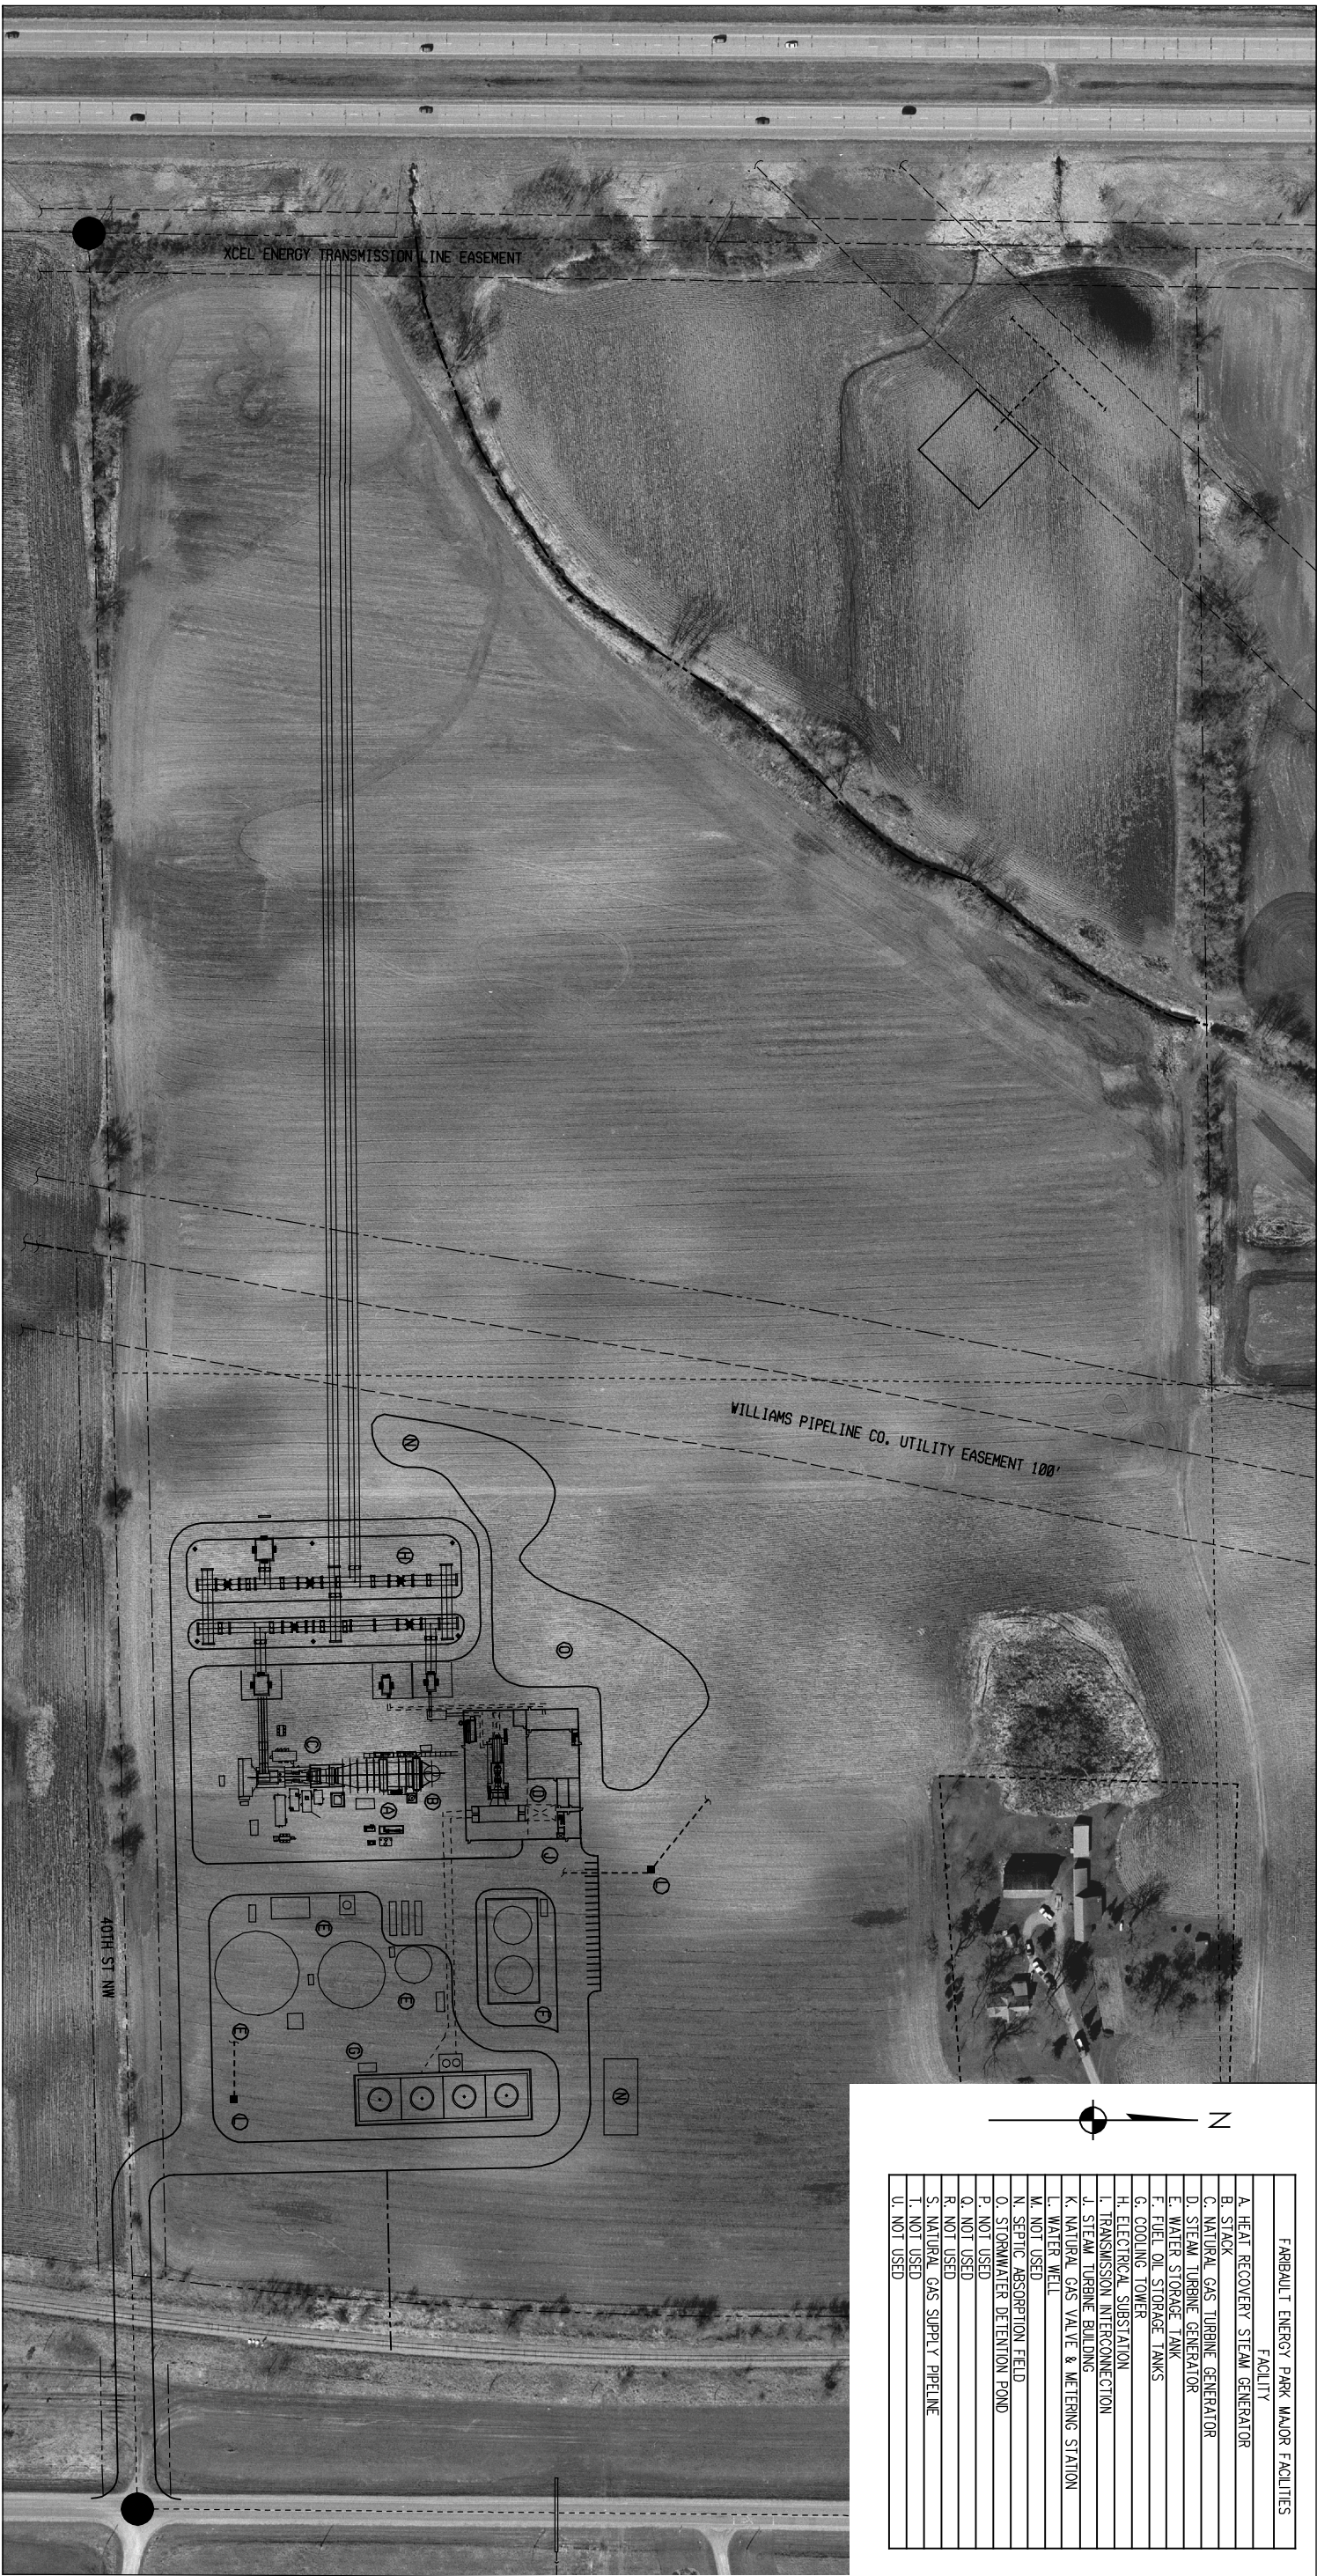
Concept Plan
Alternate Site
Proposed Transmission Lines
Figure 4

CONCEPT PLAN
